# **EXHIBIT No. 5**

ARCCA, INCORPORATED  
146 N CANAL STREET, SUITE 300  
SEATTLE, WA 98103  
PHONE 877-942-7222 FAX 206-547-0759  
www.arcca.com

Re: *Quinn, Dennis v. Marie Ronkar*  
ARCCA Case No.: 3691-015

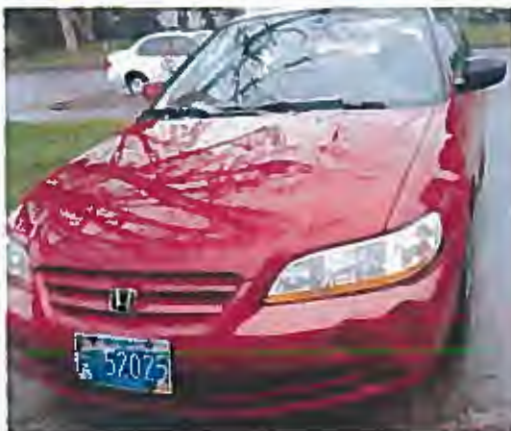
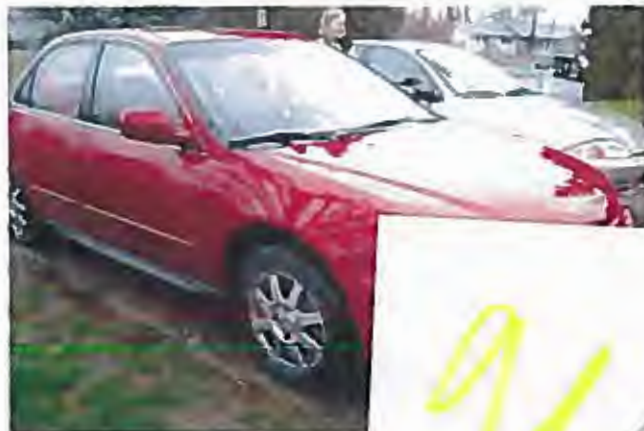
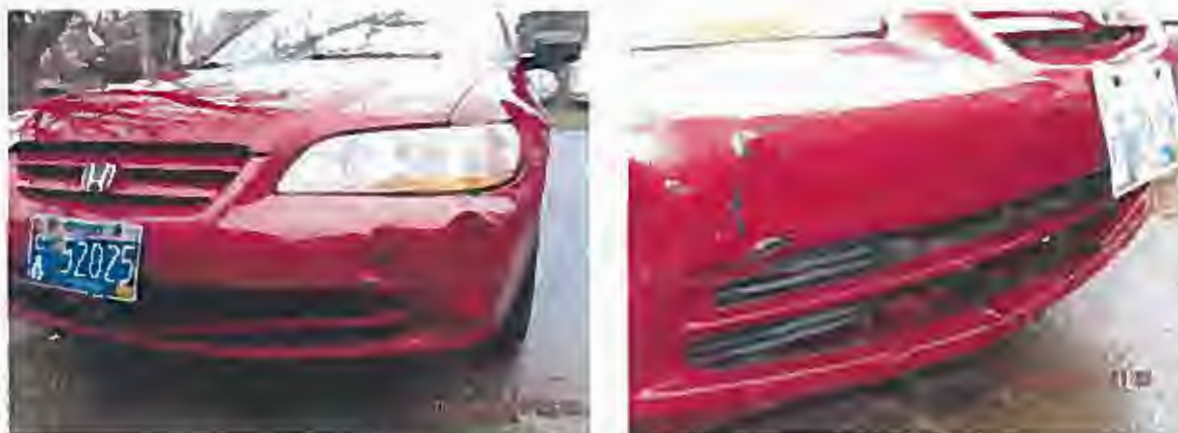
Figure 2: Reproductions of photographs of the incident 2002 Honda Accord

The photographs of the incident Honda depicted multiple paint gouges and scrapes to the front bumper cover, which was also dented on the right and left corners (Figure 2). The lower grille was fractured, and the front license plate was bent. Considering the damage to the rear of the subject Toyota, and the contact pattern between the two vehicles during the subject incident, the crush to the right and left side of the Honda's front bumper were concluded to be pre-existing and unrelated to the subject incident. Ms. Walters also stated that the Honda had prior damage.

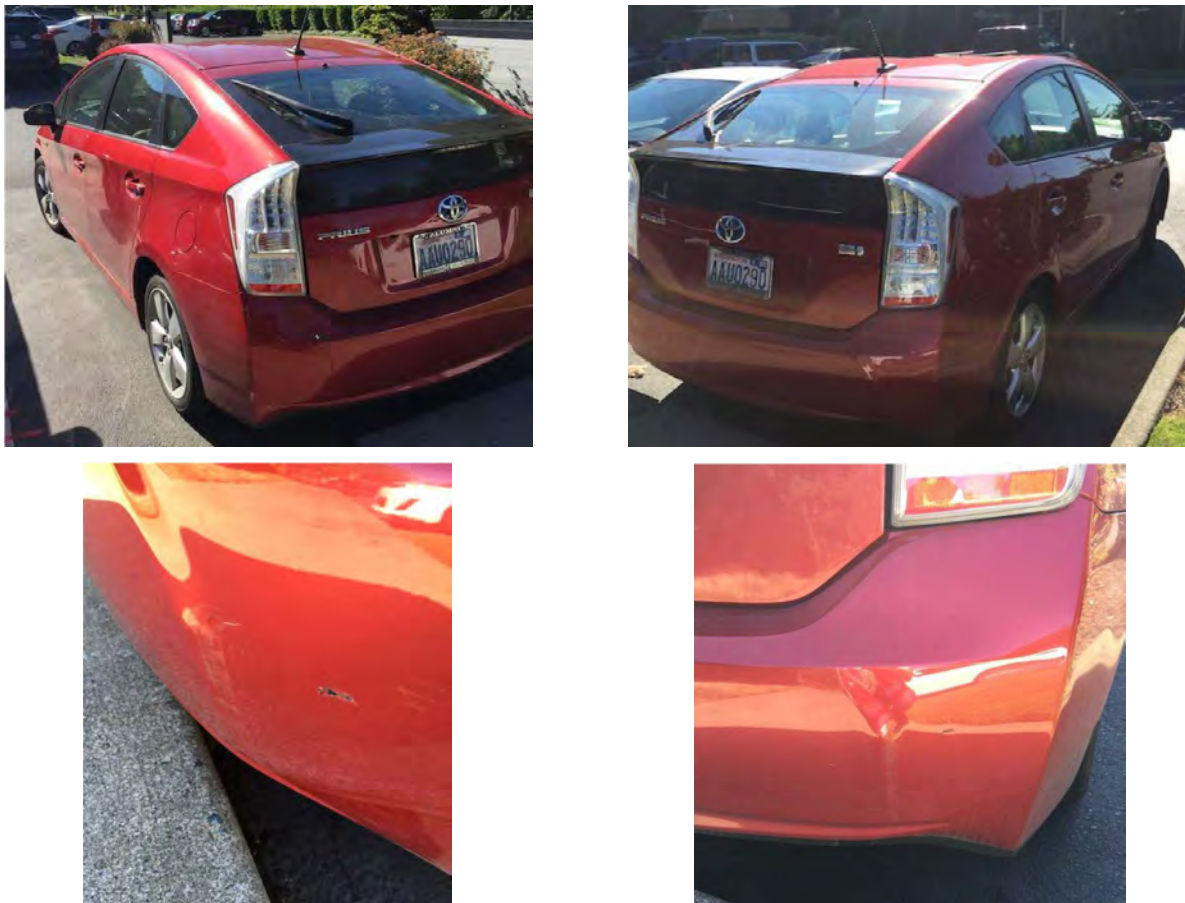
**Figure 1: Reproductions of photographs of the subject 2010 Toyota Prius**

Energy-based crush analyses have been shown to represent valid and accurate methods for determining the severity of automobile collisions.<sup>13,14,15,16,17</sup> Analyses of the photographs and geometric measurements of the subject 2010 Toyota Prius revealed the damage due to the subject incident. An energy crush analysis<sup>18</sup> indicates that a single 10 miles per hour (mph) flat barrier impact to the rear of an exemplar Toyota Prius would result in significant and visibly noticeable crush across the entirety of the subject Prius' rear structure, with a residual crush of 5.0 inches. Therefore, the energy crush analysis shows significantly greater deformation would occur in a 10 mph Delta-V (the Delta-V is the change in velocity of the vehicle from its pre-impact, initial velocity, to its post-impact velocity) impact than that of the subject incident.<sup>19</sup> The lack of significant structural crush to the entire rear of the subject Toyota Prius indicates a collision resulting in a Delta-V significantly below 10 mph.

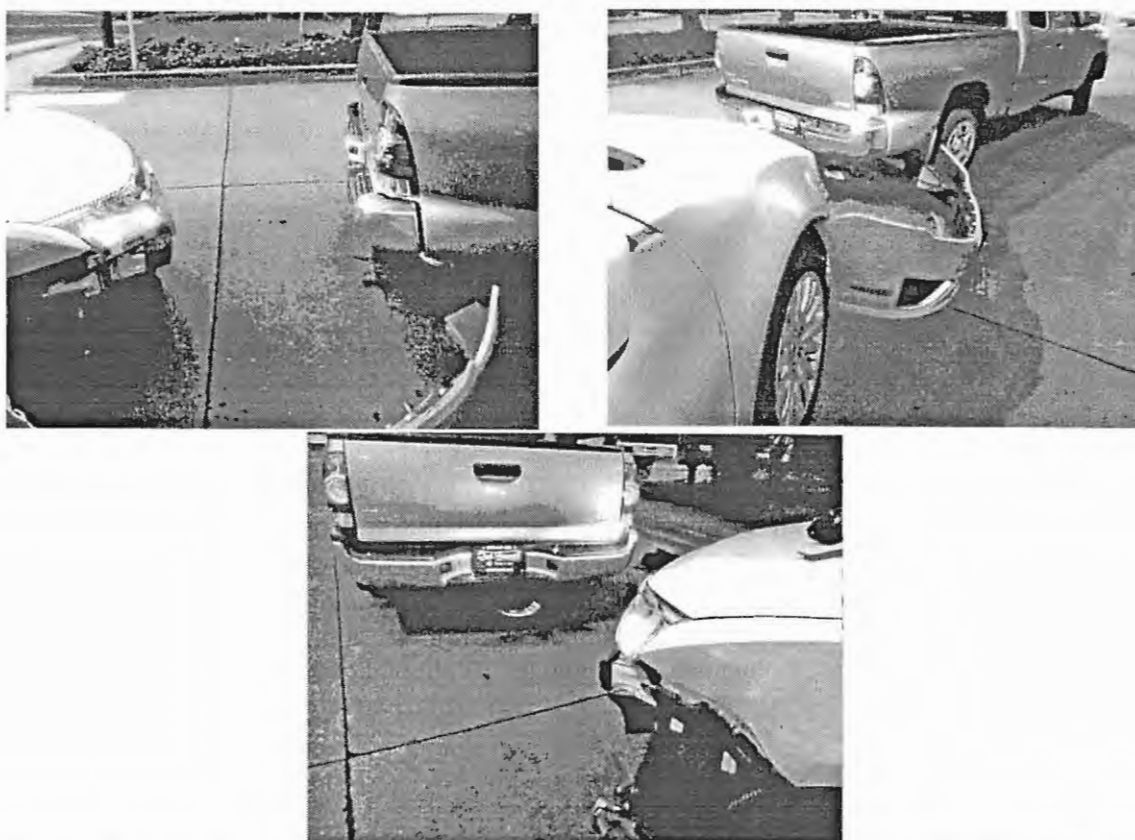
**Figure 2: Reproductions of photographs of the incident 2011 Ford Fusion and subject 2015 Toyota Tacoma**

The repair estimate for the 2011 Ford Fusion indicated damage to the front bumper cover, absorber, impact bar, bumper grille/surround, valance, left/right bezel, left/right insert panel, left side retainer, left impact bar stud, license bracket, right side retainer, grille mount panel pin, left/right headlamp assembly, left side marker lamp, and lower deflector rivet. Additionally, the incident Ford required alignment to the right fender and hood. The photographs depicted the front bumper cover detached from the vehicle, except for the far right corner (Figure 2).

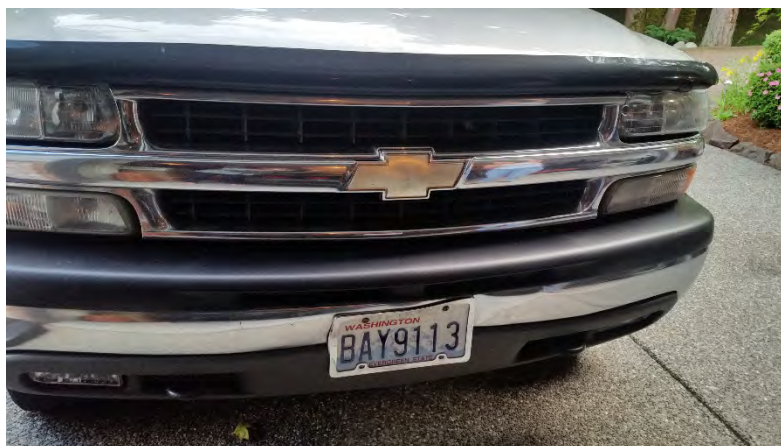
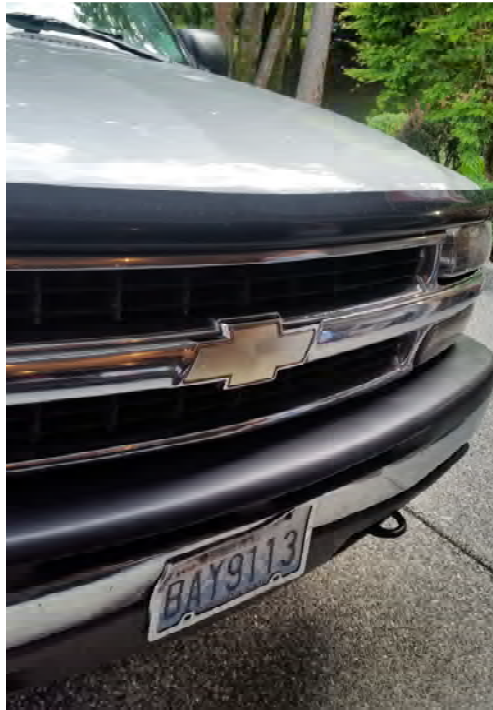
**Figure 2: Reproductions of photographs of the incident 2004 Chevrolet Tahoe**

The photographs of the 2004 Chevrolet Tahoe depicted a dent to the front bumper face near the left of the license plate (Figure 2). There was no crush to the grille, headlamps, or hood.

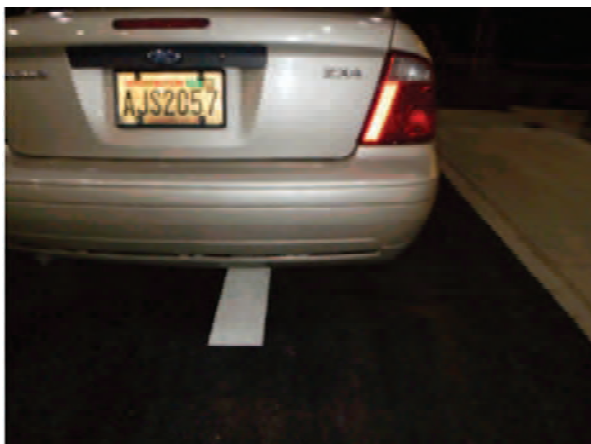
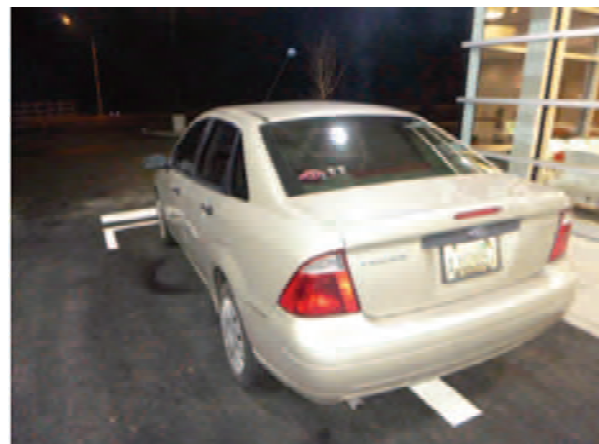
**Figure 2: Photographic reproductions of the incident Ford Focus**

The photographs of the incident Ford Focus depicted no damage to the rear bumper structures (Figure 2).

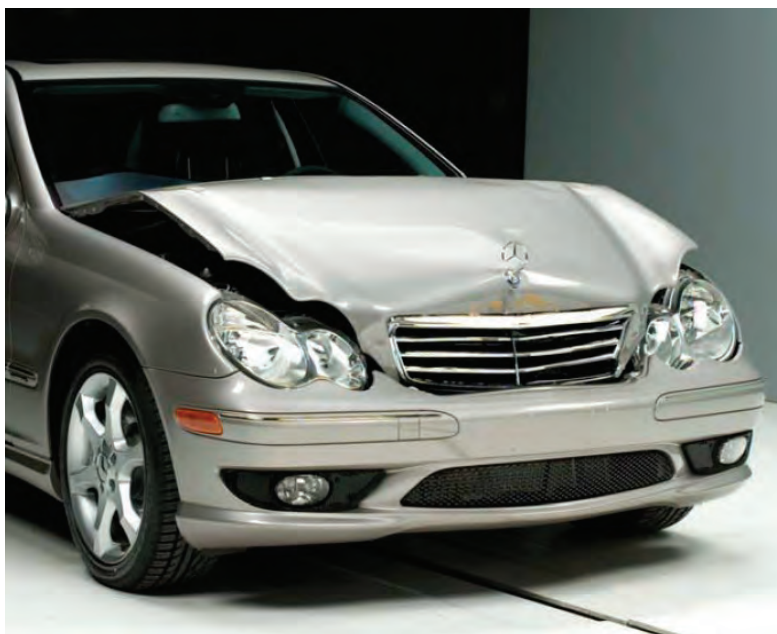
**Figure 3. Test Mercedes C-class after 6.2 mile-per-hour impact**

The IIHS tested several cars of the same era from the same manufacturer as the subject 2013 Mercedes Benz, as well as vehicles from other manufacturers. In a 6.2 mph frontal impact into a flat barrier, the test vehicles sustained comparable if not more significant damage to the front bumper covers, hood, grill, front fender, among other parts in some tests. A test C-class Mercedes is shown in Figure 3. Thus, because the test vehicles in the IIHS rear impact test sustained greater damage, the severity and energy transfer of the IIHS impact is comparable, if not greater than, the severity of the subject incident, and places the subject incident speed more comparable to the test speed of 6.2 mph.

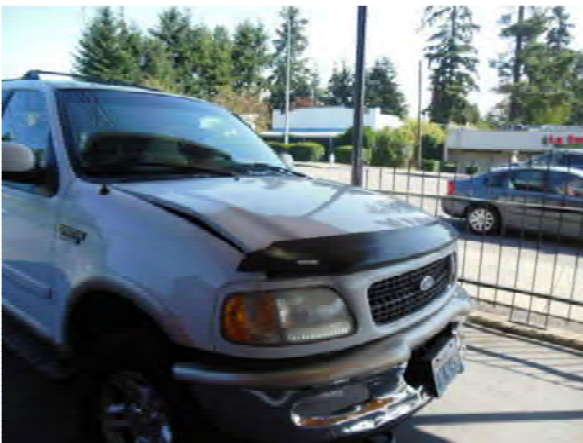
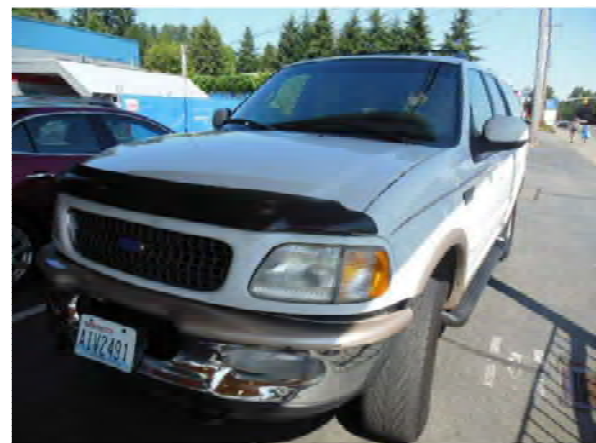
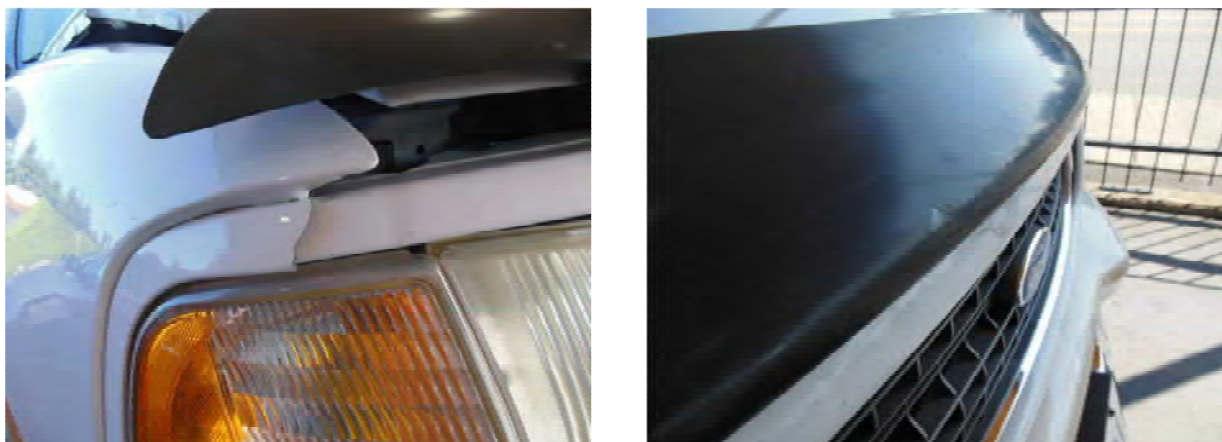
**Figure 2: Reproductions of photographs of the incident 1997 Ford Expedition**

The repair documents for the incident 1997 Ford Expedition indicated there was damage to the front bumper chrome, pad assembly, license bracket, left/right bumper mount plate, left/right bumper side bracket, valance, grille, hood, deflector wraparound, and left/right nameplate. The photographs depicted crush to the hood and a crack to the right side of the grille (Figure 2).

Newton's Third Law of Motion states that for every action there is an equal and opposite reaction. This law dictates that a scientific analysis of the loads sustained by the incident Ford Expedition can be used to resolve the loads sustained by the subject Toyota RAV4. That is, the loads sustained by the incident Ford are equal and opposite to those of the subject Toyota. Energy-based crush analyses have been shown to represent valid and accurate methods for determining the severity of automobile collisions.<sup>13,14,15,16,17</sup> Analyses of the photograph and geometric measurements along with the repair record of the incident 1997 Ford Expedition revealed the damage due to the subject incident. An energy crush analysis<sup>18</sup> indicates that a single 10 miles per hour (mph) flat barrier impact to the front of an exemplar Ford Expedition would result in significant and visibly noticeable crush across the entirety of the incident Ford's front structure, with a residual crush of 4.0 inches. Therefore, the energy crush analysis shows significantly greater deformation would occur in a 10 mph Delta-V (the Delta-V is the change in velocity of the vehicle from its pre-impact, initial velocity, to its post-impact velocity) impact than that of the subject incident.<sup>19</sup> The lack of significant structural crush to the entire front of the incident Ford indicates a collision resulting in a Delta-V significantly below 10 mph. Using the Conservation of Momentum and accounting for restitution, the subject Toyota experienced a Delta-V (the Delta-V is the change in velocity of the vehicle from its pre-impact, initial velocity, to its post-impact velocity) of significantly less than 15.5 mph.<sup>20,21</sup>

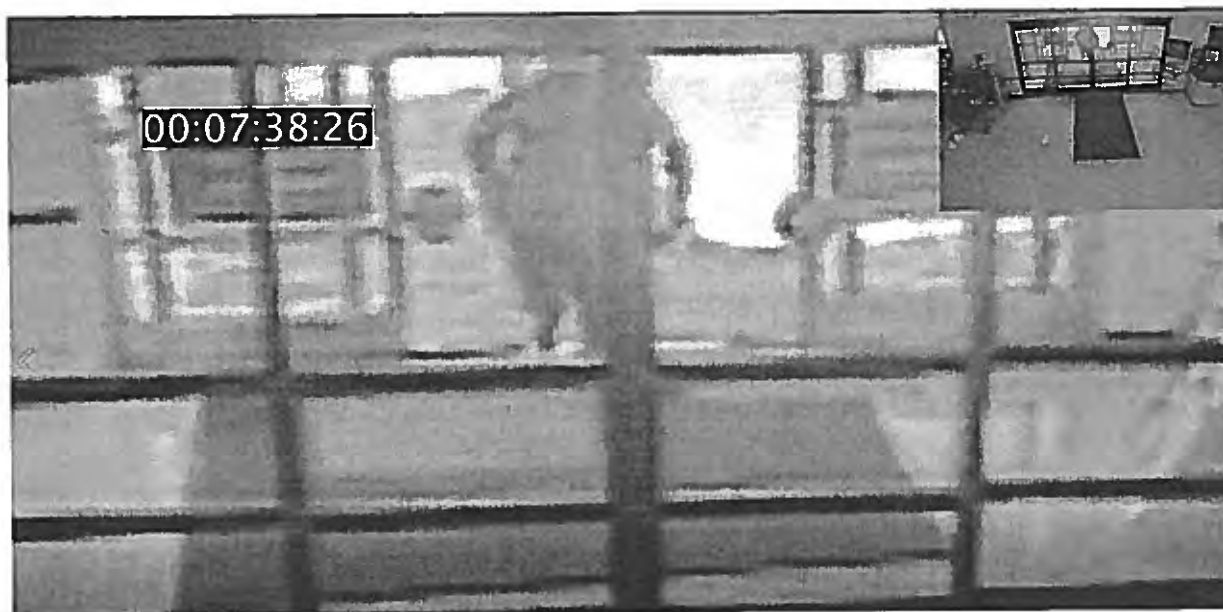
As she crosses the metal threshold, her foot appears to catch on a floor mat in the foyer, resulting in Ms. Hollingshead falling forward into the inner doors of the foyer (Figure 2).

**Figure 2: Screen shot of enhanced surveillance footage depicting Ms. Hollingshead tripping over the floor mat in the store foyer.**

As Ms. Hollingshead contacts the floor mat, the surveillance footage shows the right side of the mat curling upwards and temporarily folding over. Ms. Hollingshead testified that, *"as I was walking in, I had the sensation of being tripped, and that's when I went flying and hit the second set of doors"*. She further indicated that she noticed the mat was buckled after the incident, but did not know whether it was buckled prior to her entrance.

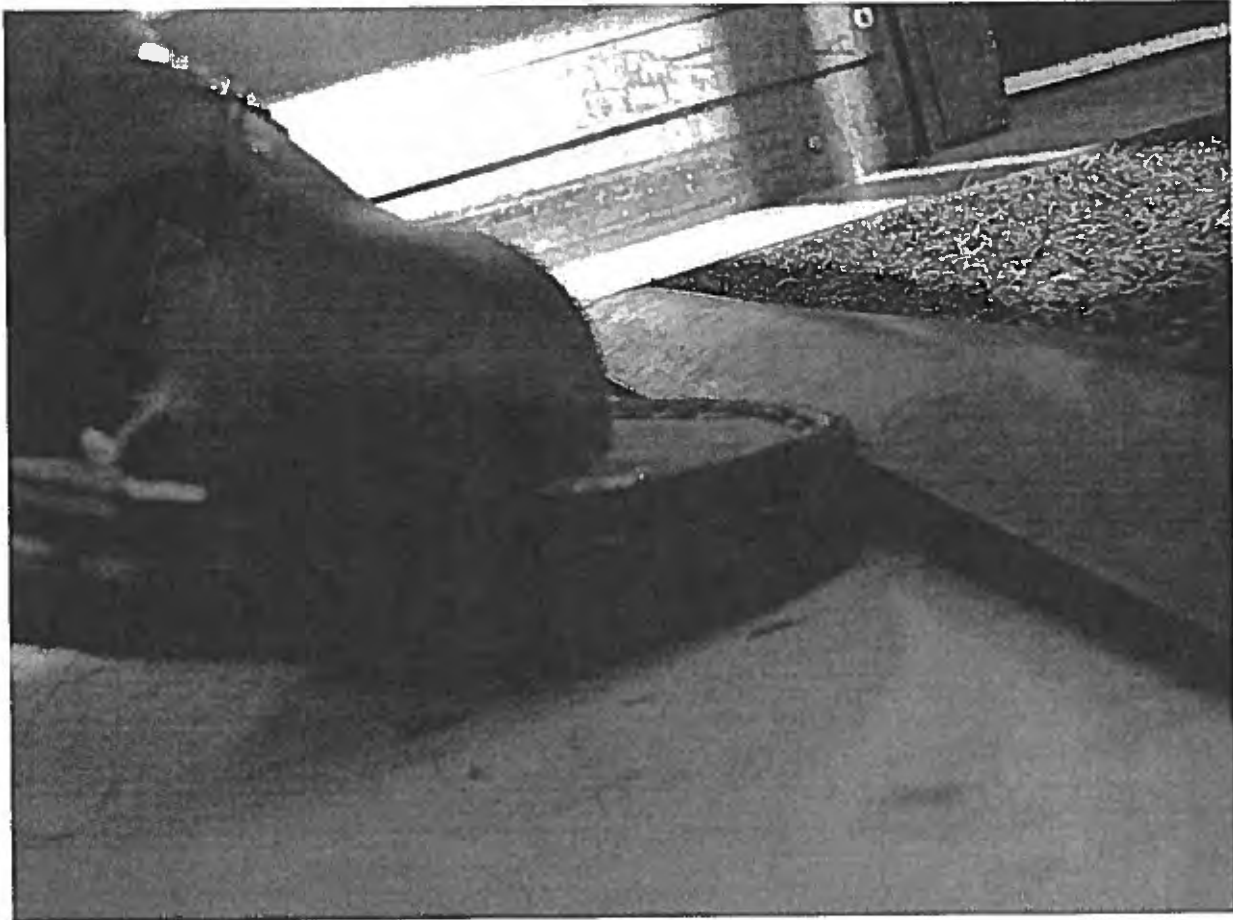
As can be seen in Figure 6, the stitching on the front edge of Ms. Hollingshead's shoes allows for an additional mechanism to snag the carpet. As noted above, the shoes showed signs of age and wear and tear and would not necessarily stay secured to the sole of Ms. Hollingshead's foot and could snag the floor mat. During my inspection, I was able to repeatedly snag the floor mat when the edge was raised 0.125". Again, this value is well below the above mentioned 0.25".

**Figure 6. Ms. Hollingshead's shoe**

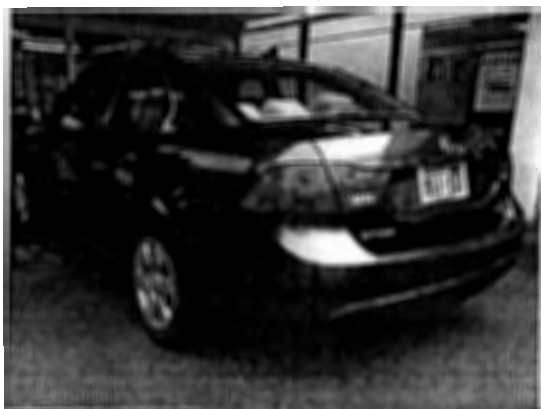
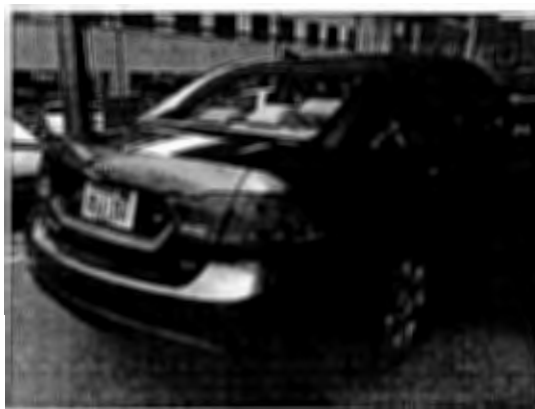
The repair documents for the subject Kia reported damage to the rear bumper cover. The photographs depicted bolt marks to the rear bumper cover (Figure 1). There was no significant crush or displacement to the rear components of the subject vehicle.

**Figure 1: Reproductions of photographs of the subject 2009 Kia Optima**

The Insurance Institute for Highway Safety (IIHS) performs low-speed tests on vehicles to assess the performance of the vehicles' bumpers and the damage incurred. The damage to the subject Kia Optima, defined by the photographic reproductions, and confirmed by the repair estimate, was used to perform a damage threshold speed change analysis.<sup>8</sup> The IIHS tested an exemplar 2009 Kia Optima in a 6.2 miles per hour (mph) rear impact into a flat barrier.<sup>9</sup> The test Kia sustained damage to the rear deck lid, rear body panel, rear bumper cover, rear bumper absorber, rear bumper reinforcement, and required a unibody pull. The primary damage to the subject Kia was to the rear bumper cover. Thus, because the test Kia Optima in the IIHS rear impact test sustained greater damage, the severity and energy transfer of the IIHS impact is greater compared to the severity of the subject incident. Accounting for restitution, the subject Kia experienced a Delta-V of less than 8.0 mph.

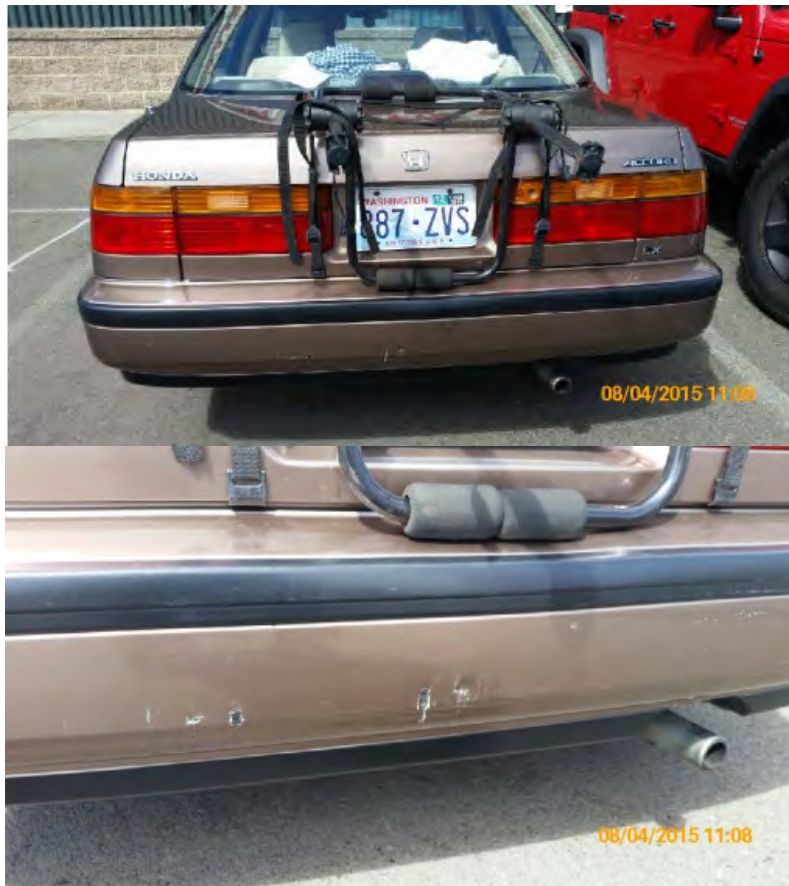
**Figure 1: Reproductions of photographs of the subject 1991 Honda Accord**

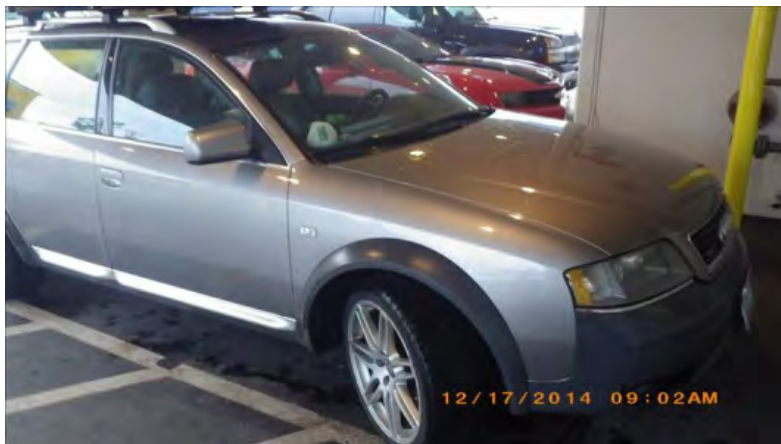
The repair documents for the incident 2003 Audi Allroad Quattro indicated there was damage to the front bumper cover, license bracket, left trim, left/right trim rivet, left/right energy absorber, and hood. The photographs depicted no residual crush to the front bumper structures (Figure 2).

**Figure 2: Reproductions of photographs of the incident 2003 Audi Allroad Quattro**
